Technical Report M9

**ENVIRONMENTAL AND NAVIGATION IMPROVEMENT
STUDY OF WOLF ISLAND
MISSISSIPPI RIVER
MILES 936.5 TO 929**

Prepared For
U.S. Army Corps of Engineers
Mississippi River Valley Division
&
Memphis District

June 2000

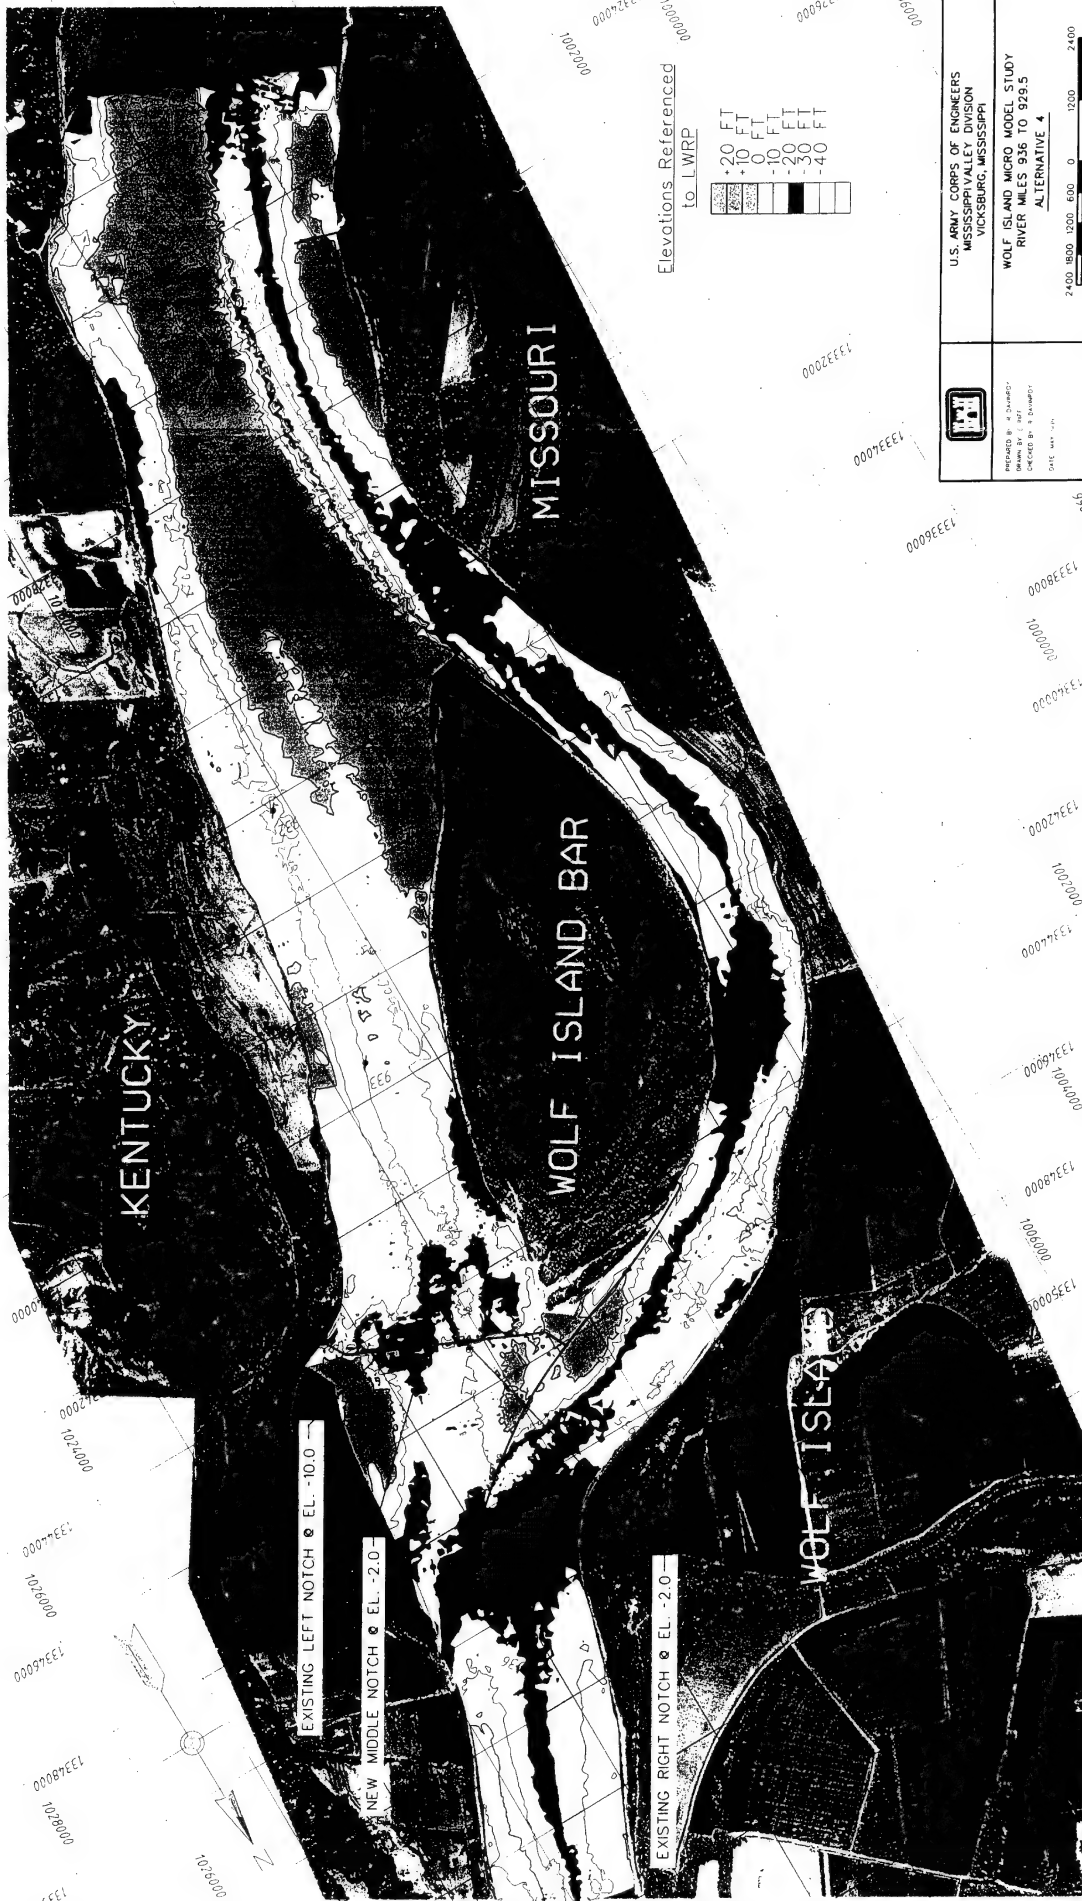
U.S. ARMY CORPS OF ENGINEERS MISSISSIPPI VALLEY DIVISION VICKSBURG, MISSISSIPPI
	WOLF ISLAND MICRO MODEL STUDY RIVER MILES 936 TO 929.5 ALTERNATIVE 4
PREPARED BY: J. J. JAMES DRAWN BY: J. J. JAMES CHECKED BY: J. J. JAMES DATE: MAY 1964	SCALE: 1" = 1000' HORIZONTAL 1" = 100' VERTICAL 2400 1800 1200 600 0 1200 2400 SHEET NO. 21

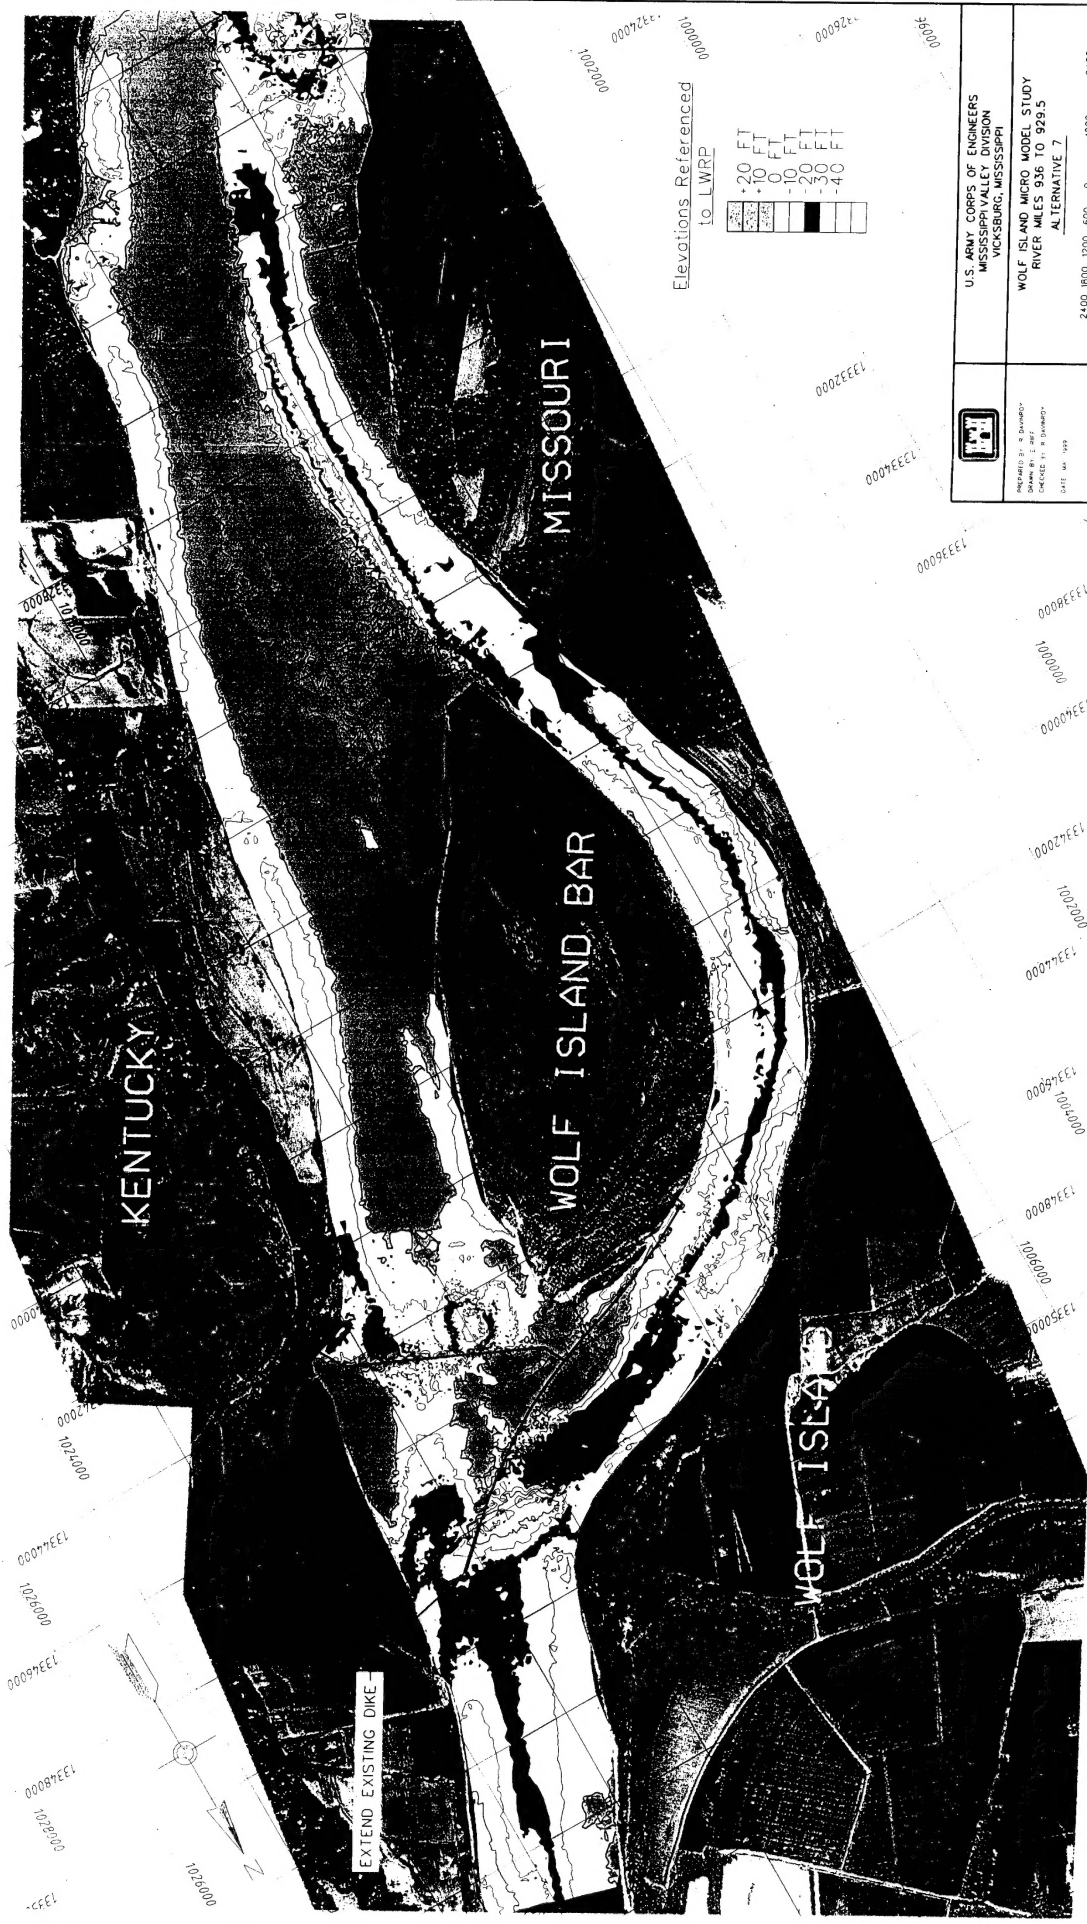
U.S. ARMY CORPS OF ENGINEERS MISSISSIPPI VALLEY DIVISION VICKSBURG, MISSISSIPPI
	WOLF ISLAND MICRO MODEL STUDY RIVER MILES 936 TO 929.5 ALTERNATIVE 7
PREPARED BY: R. D. DAVENPORT DRAWN BY: J. J. JEFF CHECKED BY: R. DAVENPORT DATE: MAR 1993	
2400 1800 1200 600 0 1200 2400	
SHEET NO. 24

From Mile 935 to the end of the model, the trends developed in Alternative 7 were very similar to the trends observed in the base test.

Scour below the right notch was slightly less than the base test, with depths between -30 feet and -40 feet LWRP. Below the notch, a channel developed against the right descending bank of Wolf Island and the crossed over to the left descending channel, which was very similar to what was observed in the base test.

From Mile 935 to the end of the model, the trends developed in Alternative 7 were very similar to the trends observed in the base test, although the crossing near Mile 931.5 was approximately 10 feet deeper than the base test.

- Alternative 7 showed that an extension of the existing longitudinal structure, combined with the closure structure of the base test, made an improvement to the channel crossing, between Miles 936 and 935. Trends within the side channel, with conditions of the closure structure left as in the base test, displayed similar trends as compared to the base test.

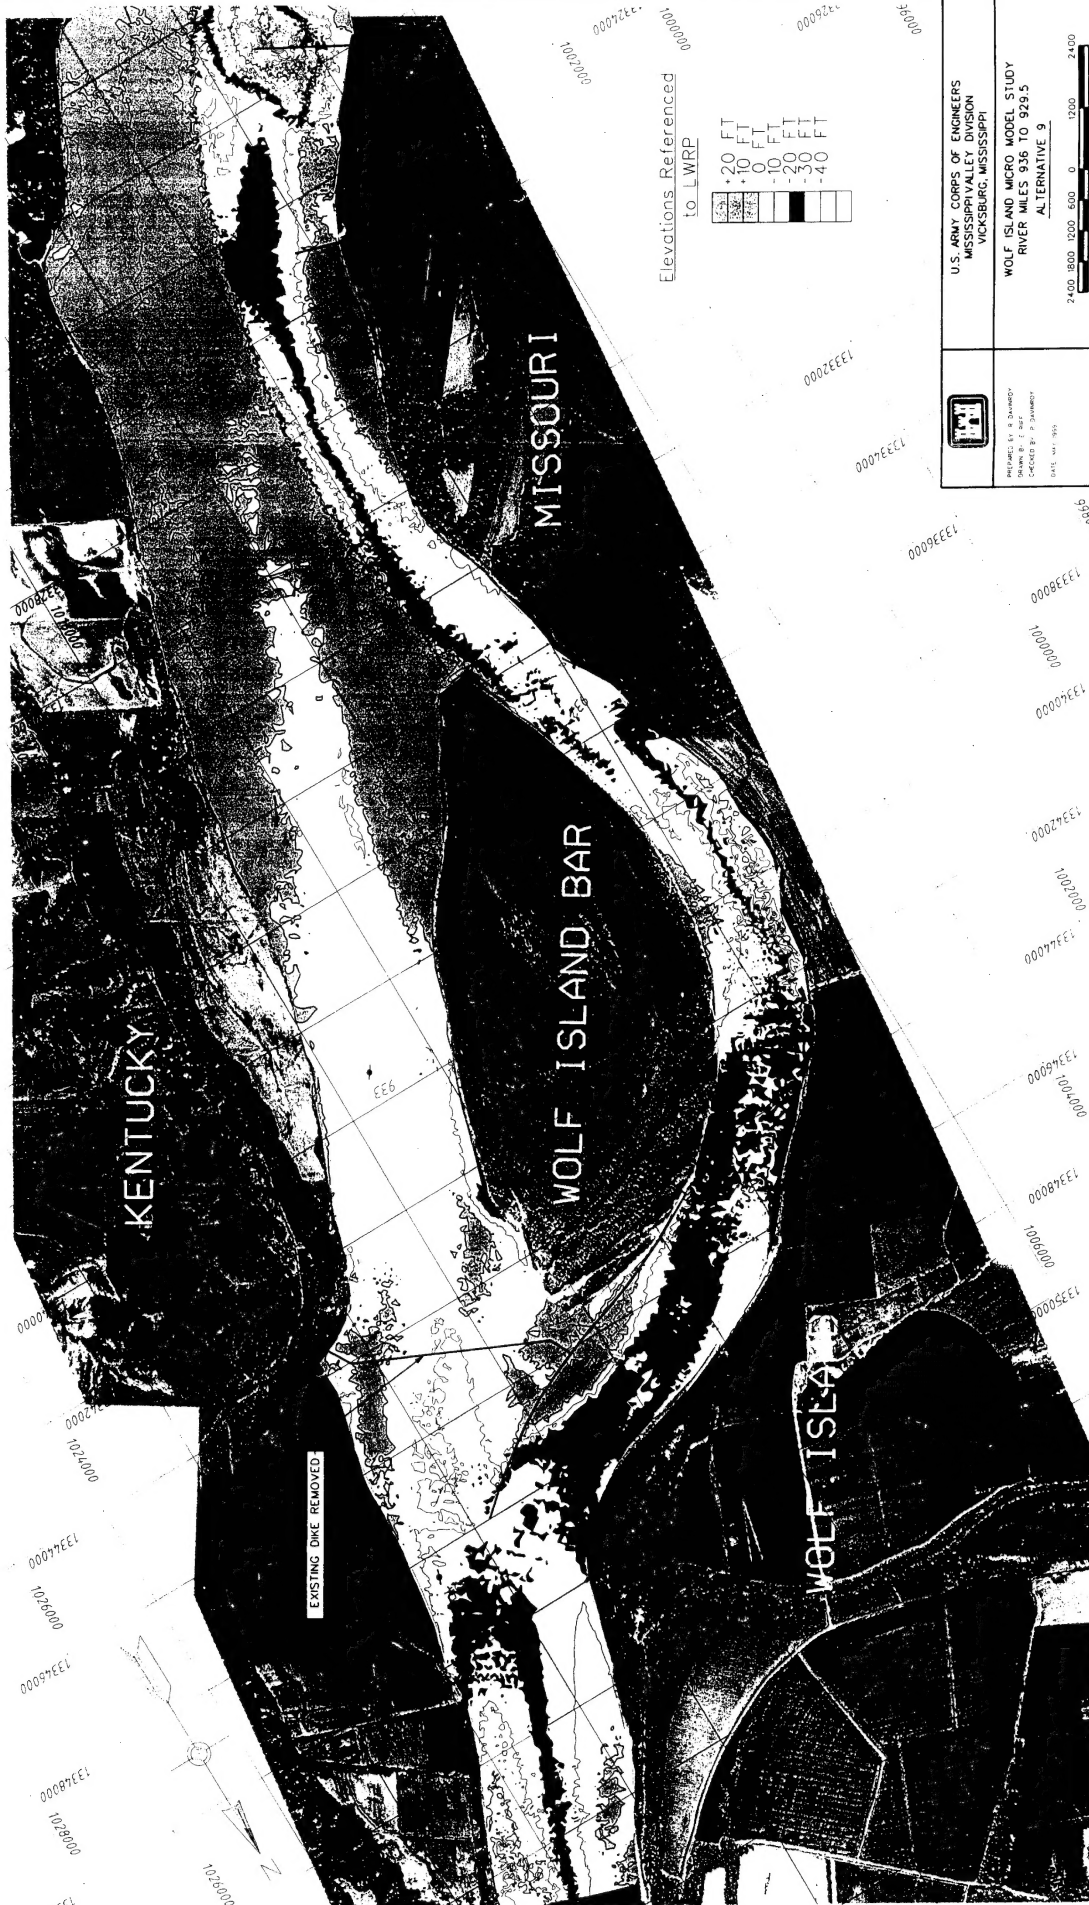
WOLF ISLAND MICRO MODEL STUDY
RIVER MILES 936 TO 929.5
ALTERNATIVE 9

Within the side channel, the scour holes below the former location of the closure structure filled in with sediment, to depths near 0 feet LWRP. The deeper channel along the left descending bank disappeared. A dominant, relatively shallow channel formed in the middle of the side channel, replacing the higher middle bar of the base test, to depths near 0 feet LWRP. Flow was evenly distributed through the entire side channel as a result of these changes. The channel along the left descending bank observed in the base test filled in with sediment, to depths between 0 and +10 feet LWRP. A scour hole still developed against the right descending bank of Wolf Island Bar similar to what was observed in the base test, to depths near -20 feet LWRP.

- Alternative 9 showed that complete removal of the closure structure, with the longitudinal dike left in place, tended to dramatically change the trends within the side channel. The side channel flow distribution trend changed from two distinct channels along the left and right descending banks, as observed in the base test, to one dominant, much shallower channel along the entire width of the side channel. In addition, navigation depths within the main channel were considerably less than the base test. This alternative showed the critical functionality of the closure structure for maintaining the existing depth diversity within the side channel.
